# THE FAILURE OF THE TACOMA NARROWS BRIDGE

A Report to the  
Honorable John M. Carmody  
Administrator, Federal Works Agency  
Washington, D. C.

## BOARD OF ENGINEERS

MARCH 28, 1941

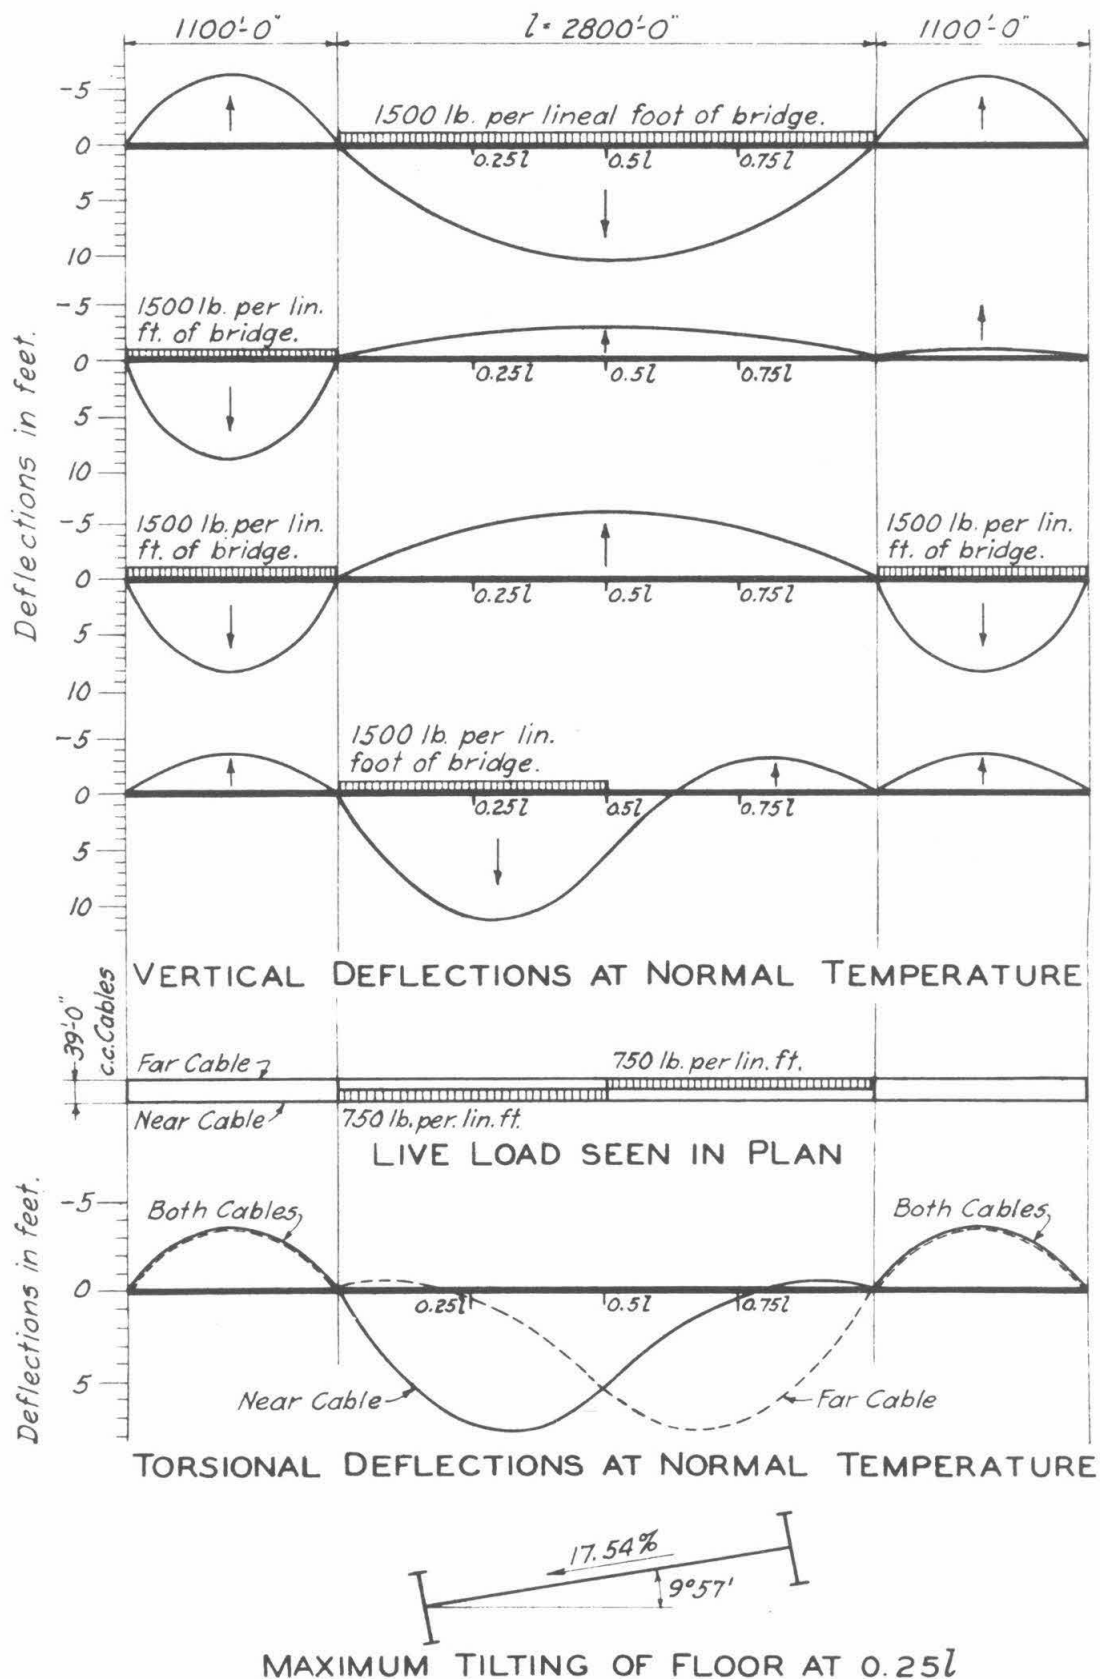
FIG.15 - VERTICAL AND TORSIONAL LIVE LOAD DEFLECTIONS OF THE TACOMA NARROWS BRIDGE.

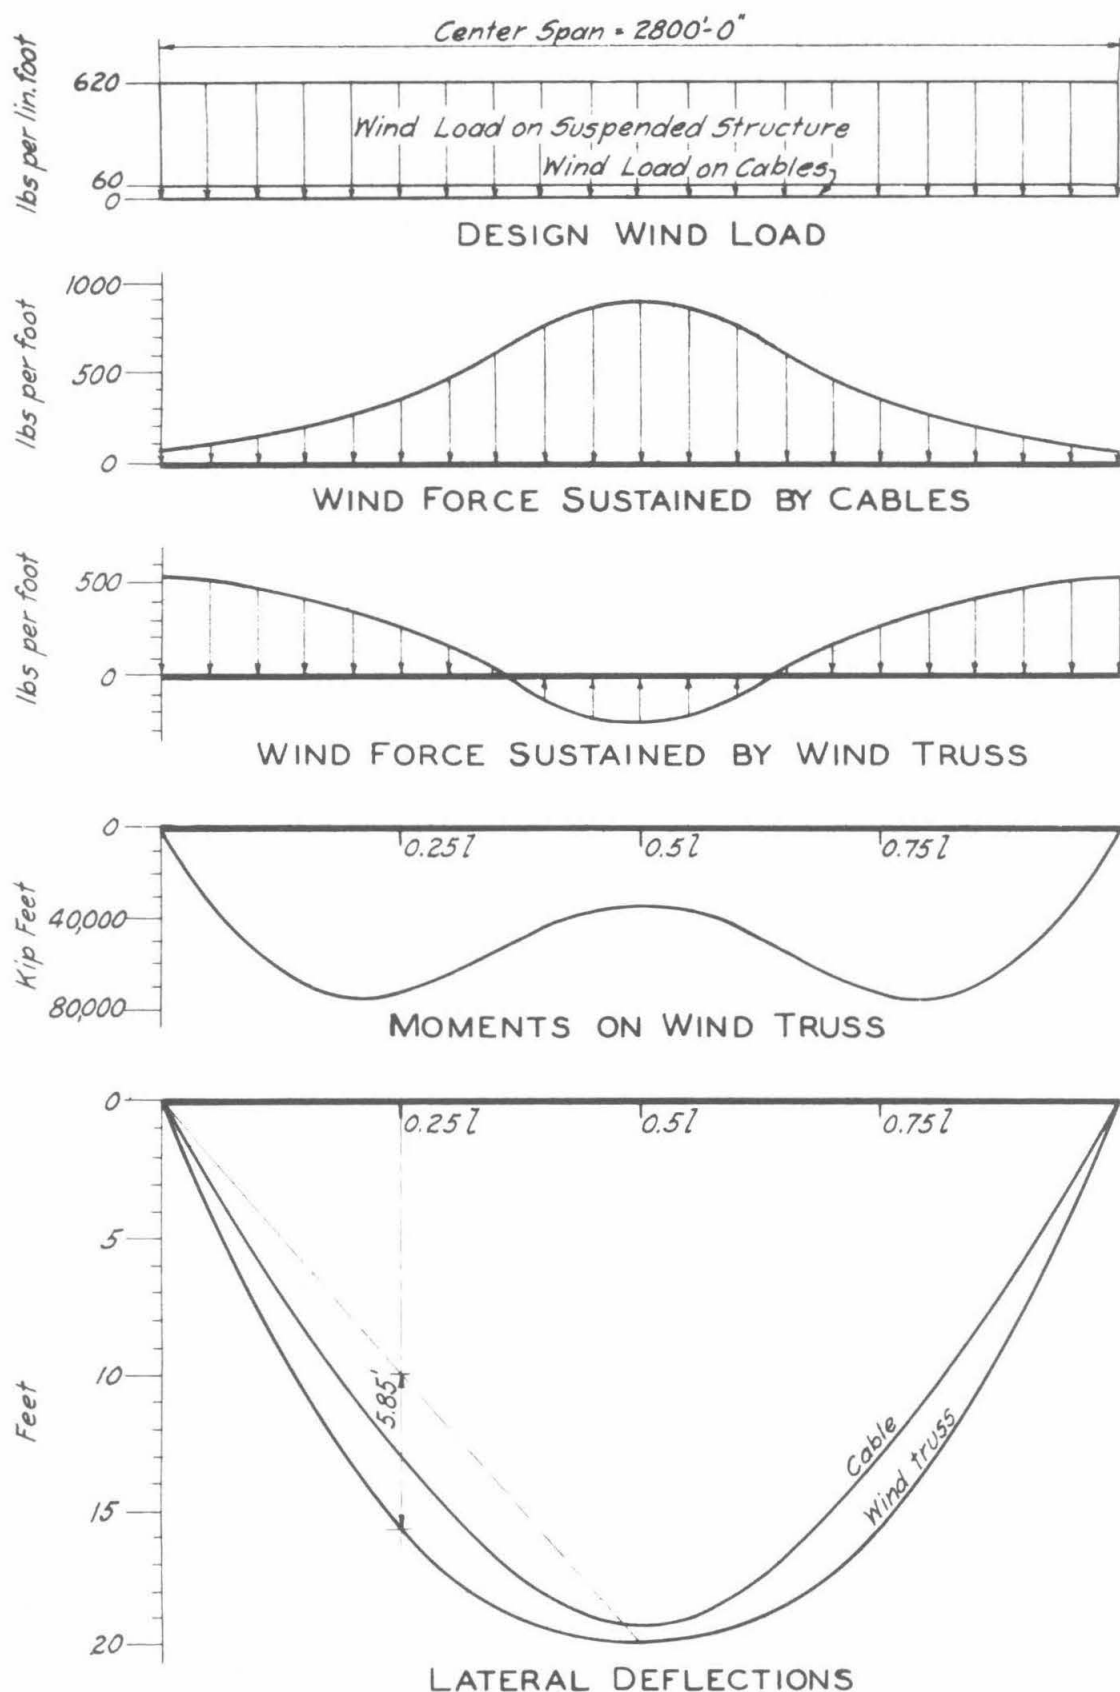
FIG.16- DISTRIBUTION OF 620 LBS PER LINEAL FOOT DESIGN WIND LOAD AND RESULTING LATERAL DEFLECTIONS OF THE TACOMA NARROWS BRIDGE.

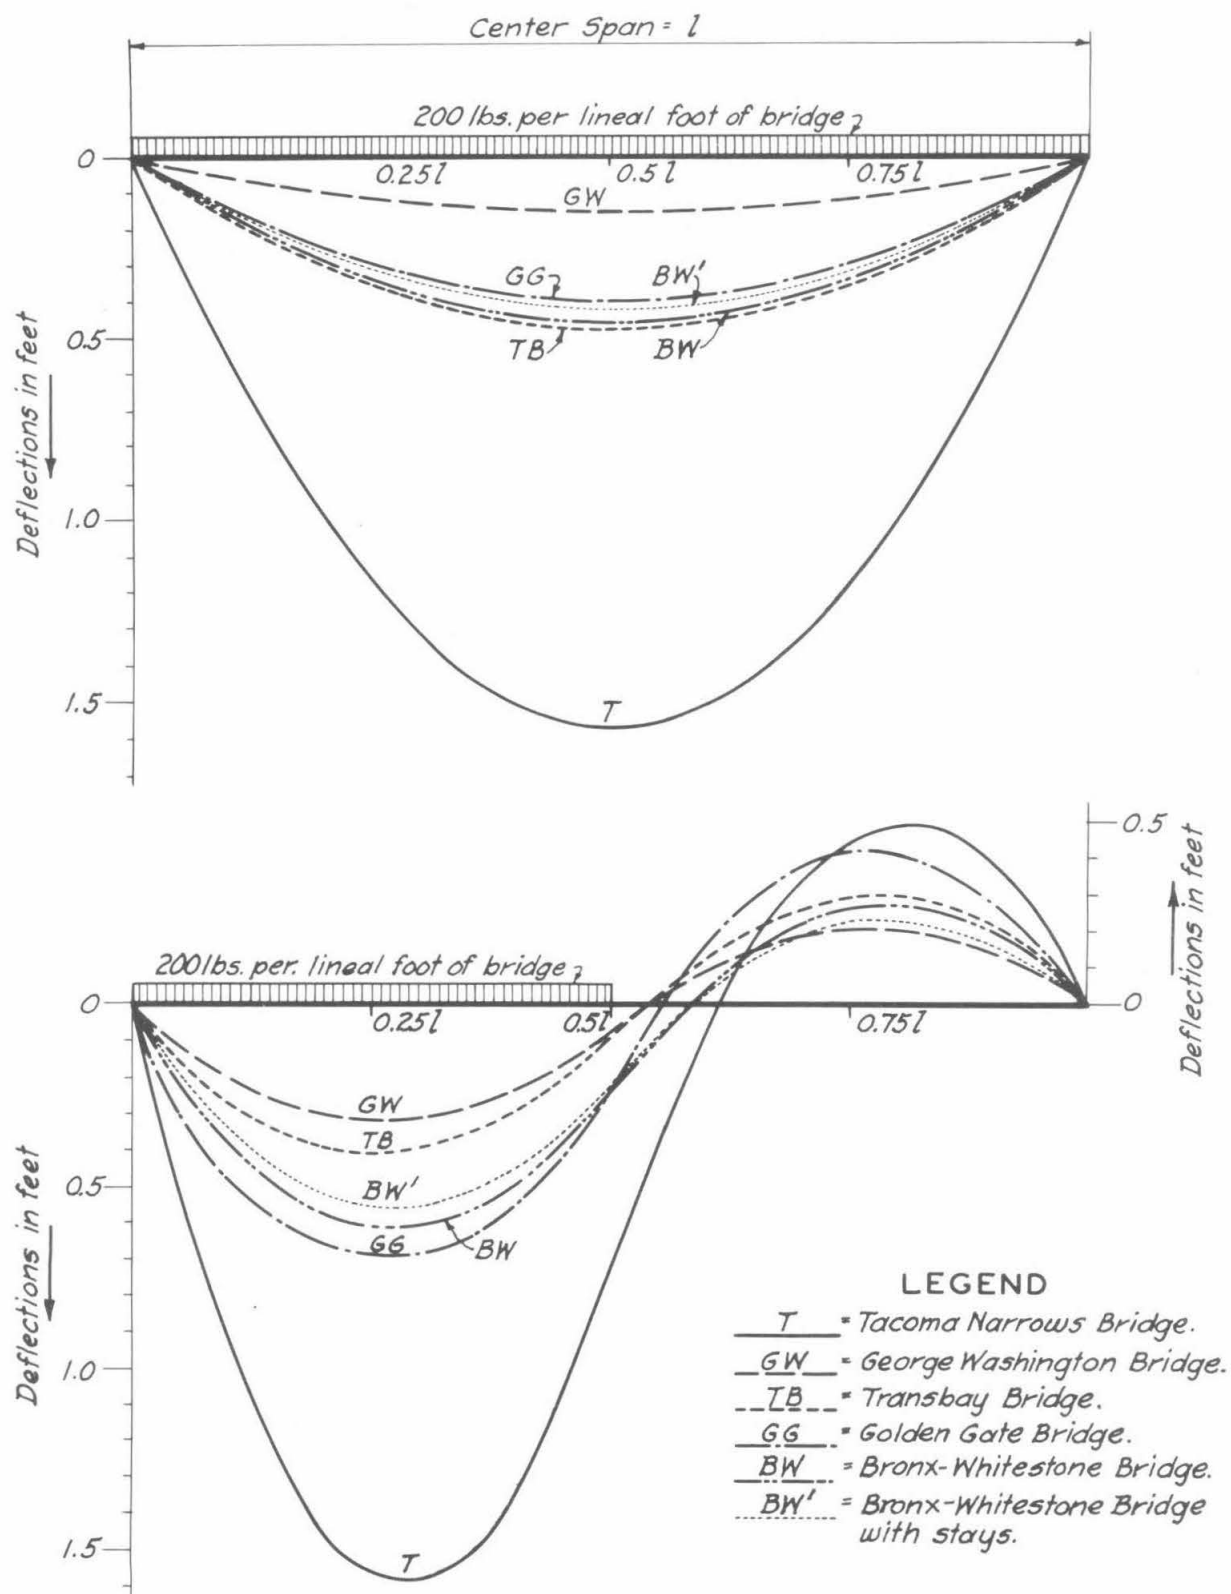
FIG.17- COMPARATIVE VERTICAL DEFLECTIONS OF THE FIVE LONGEST SUSPENSION BRIDGES DUE TO A LOAD OF 200 LBS. PER LIN. FOOT OF BRIDGE.

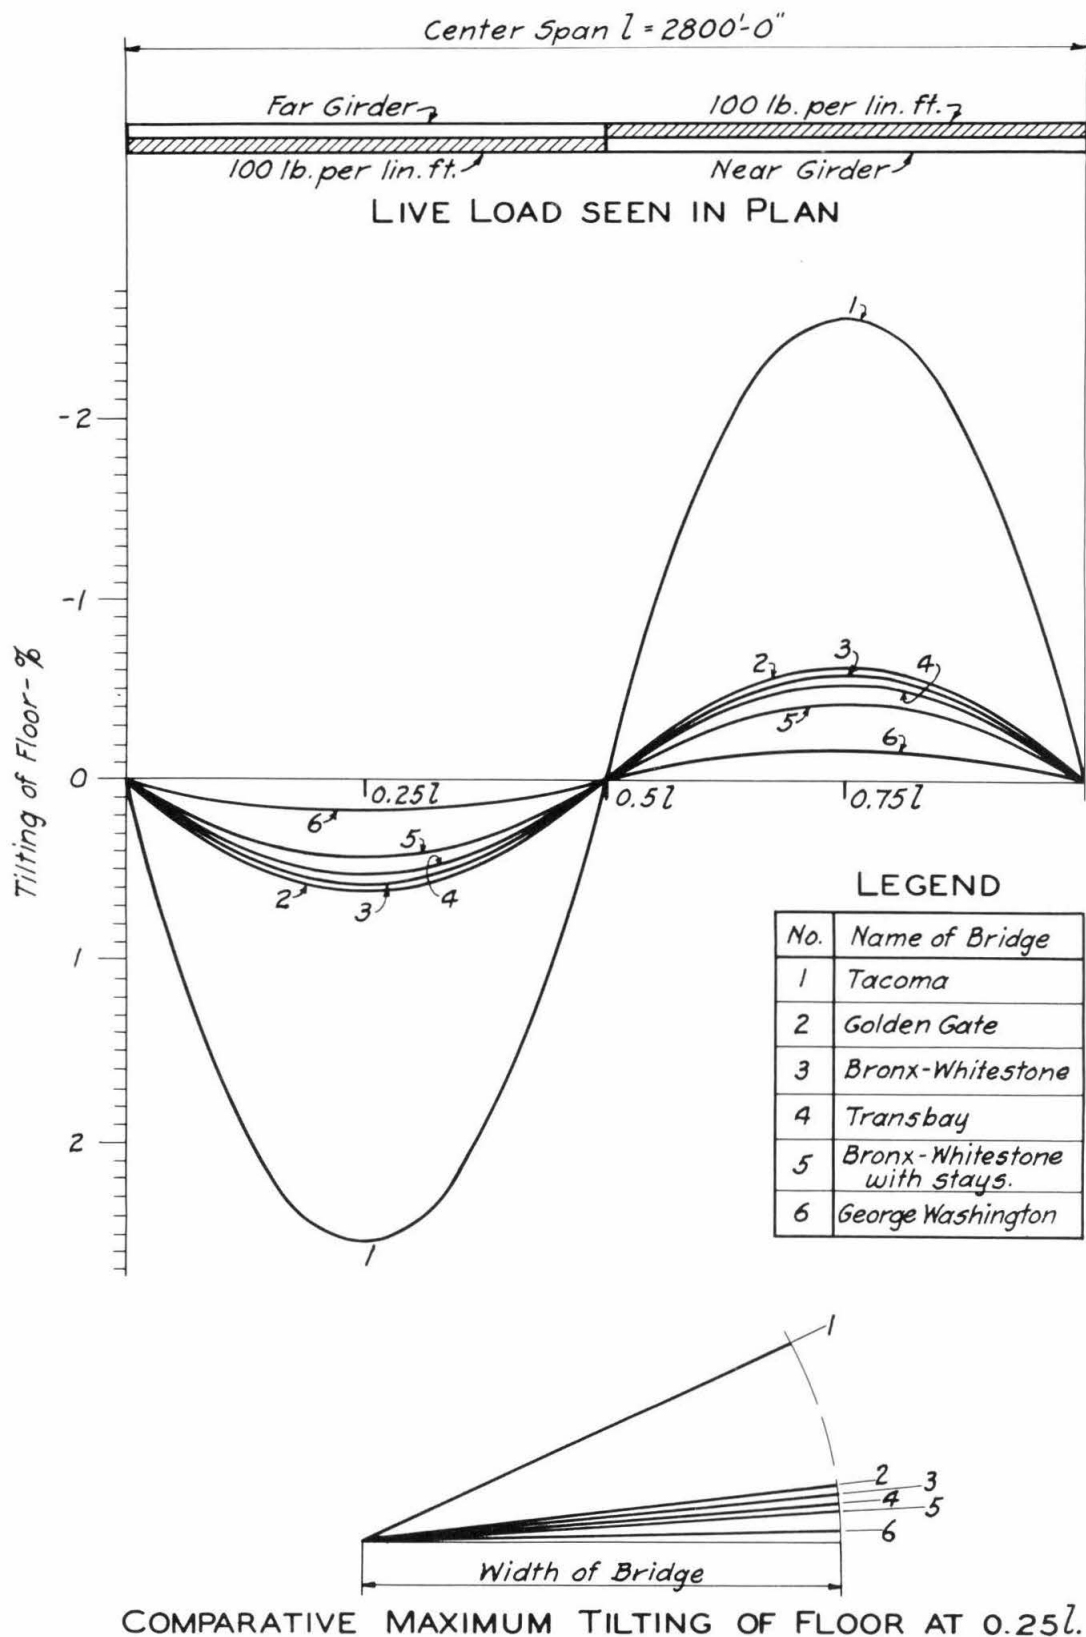
FIG.18 - COMPARATIVE TILTING OF FLOOR OF THE FIVE LONGEST SUSPENSION BRIDGES

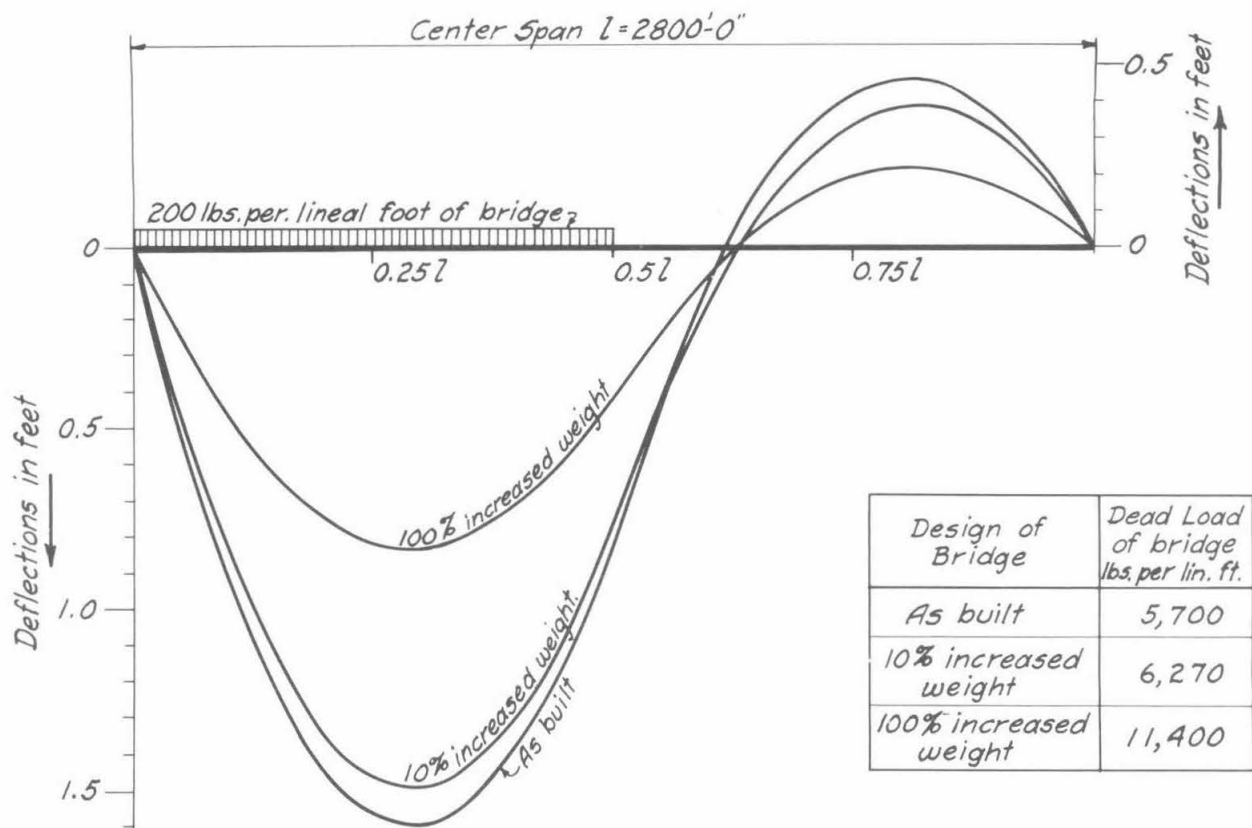
FIG.19 - EFFECT OF WEIGHT ON COMPARATIVE VERTICAL DEFLECTIONS OF THE TACOMA NARROWS BRIDGE

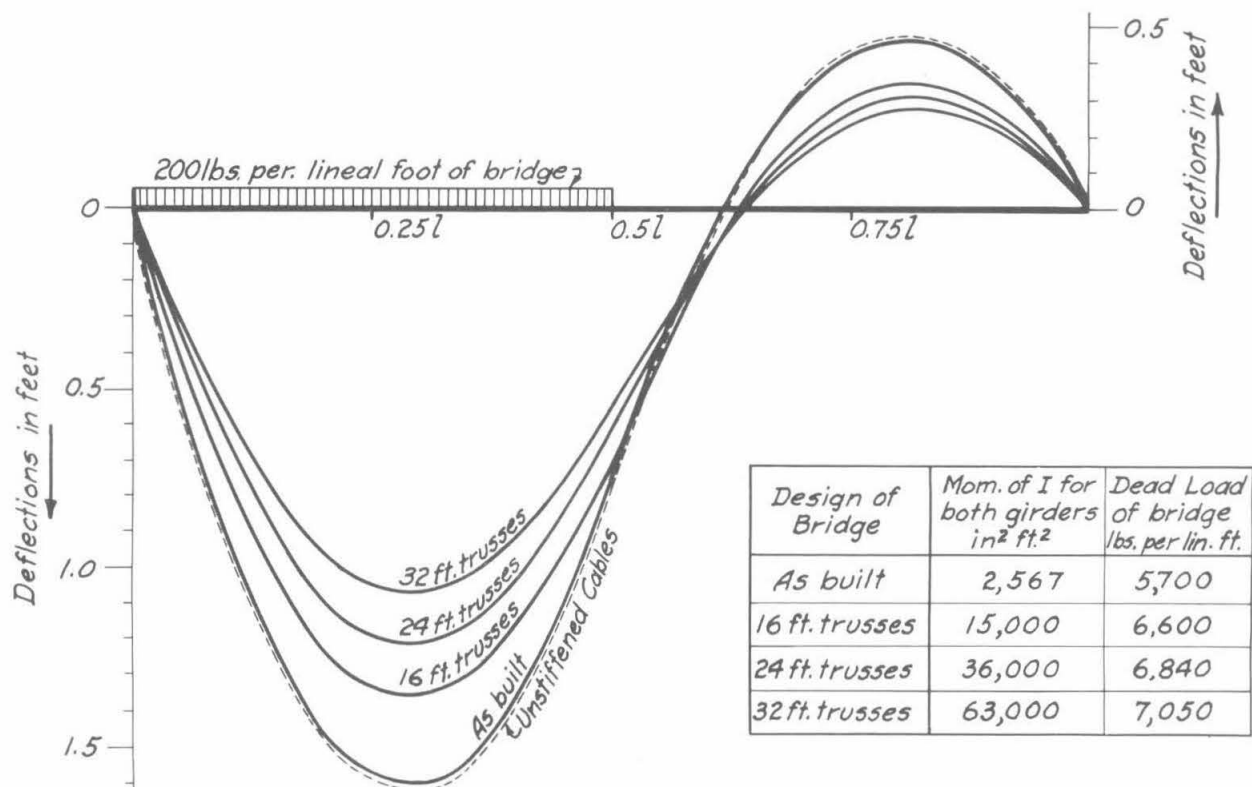
FIG.20- EFFECT OF THE RIGIDITY OF THE STIFFENING GIRDERS ON COMPARATIVE VERTICAL DEFLECTIONS OF THE TACOMA NARROWS BRIDGE.

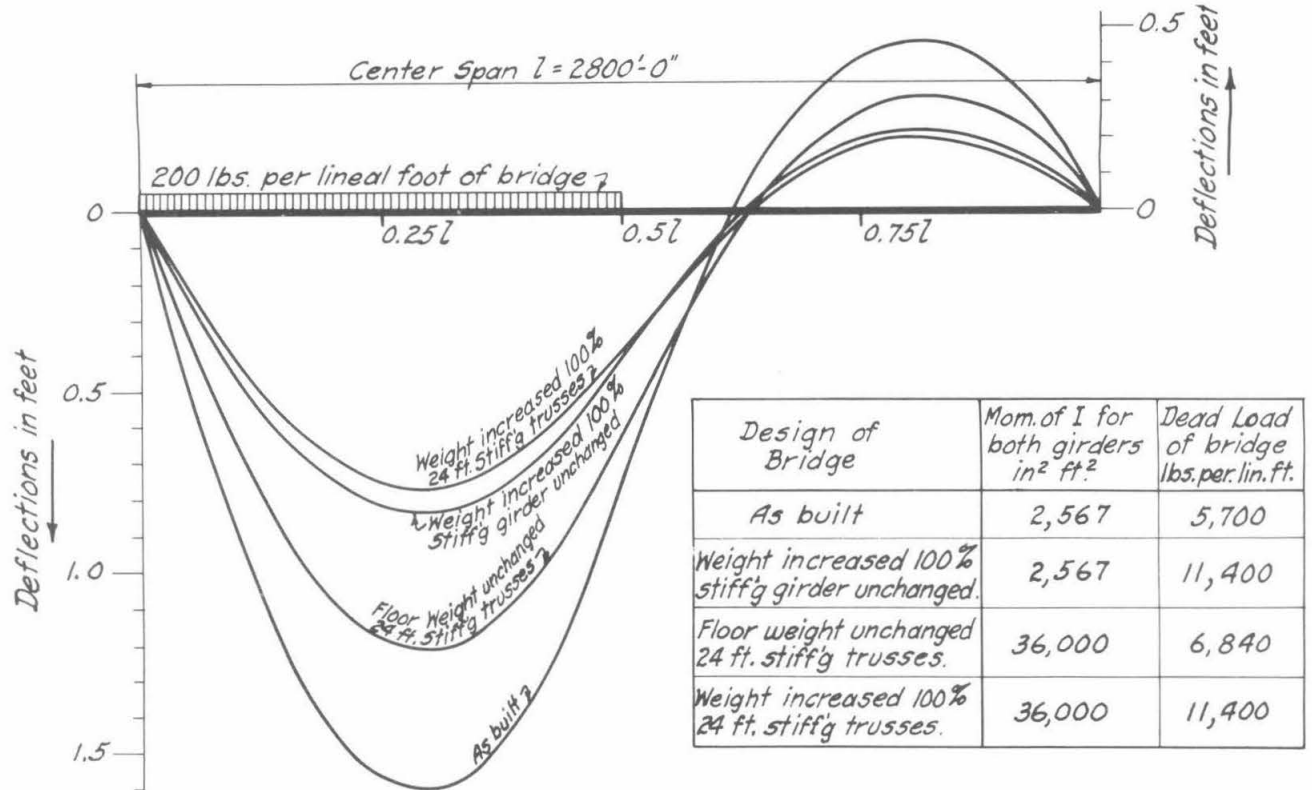
FIG.21 - COMBINED EFFECT OF INCREASED WEIGHT AND RIGIDITY OF THE STIFFENING GIRDERS ON THE COMPARATIVE VERTICAL DEFLECTIONS OF THE TACOMA NARROWS BRIDGE

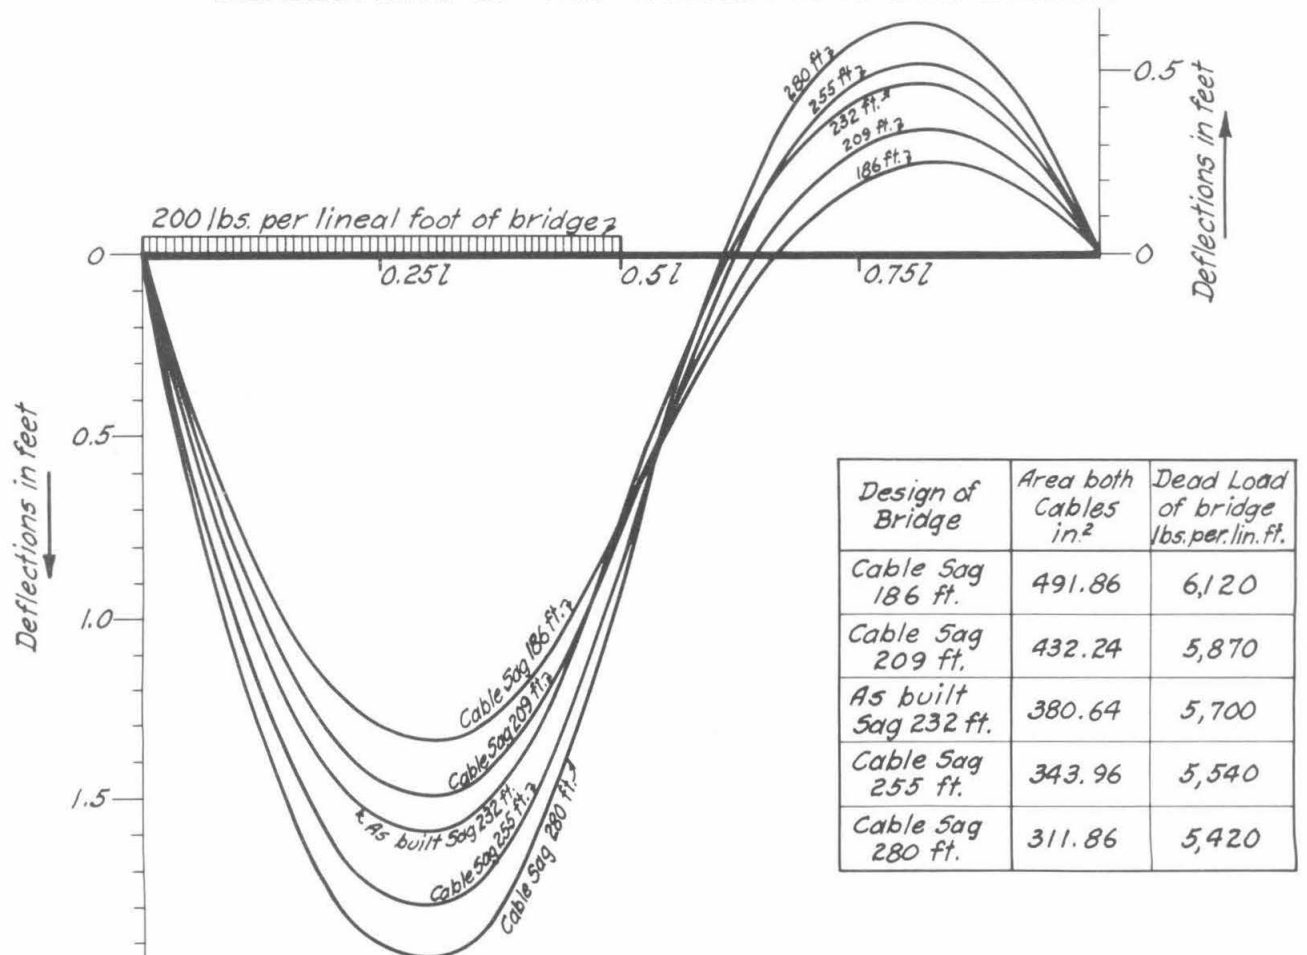
FIG.22 - EFFECT OF CABLE SAG ON COMPARATIVE VERTICAL DEFLECTIONS OF THE TACOMA NARROWS BRIDGE.

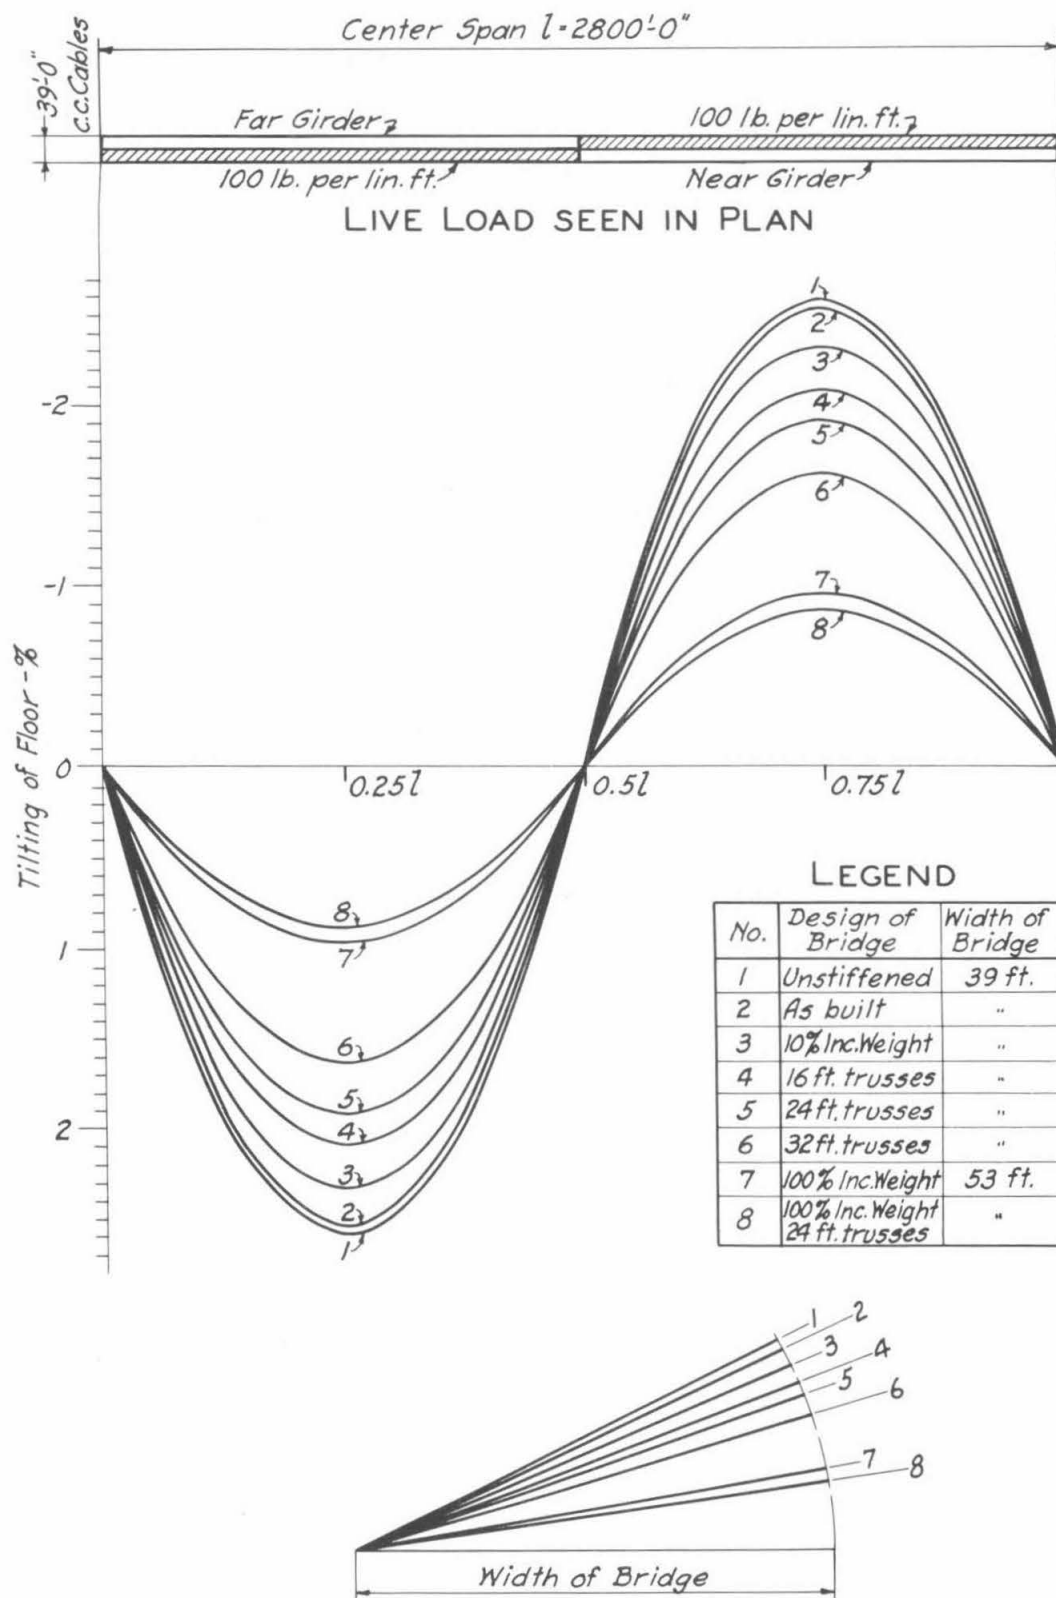
Fig. 23 illustrates the effect of width, weight and girder stiffness on torsion, and indicates that only an increase in width to 53 ft., an increase in weight by 100% and stiffening trusses 24 ft. deep, can secure a torsional rigidity approaching that of the Golden Gate Bridge.

COMPARATIVE MAXIMUM TILTING OF FLOOR AT 0.25l.

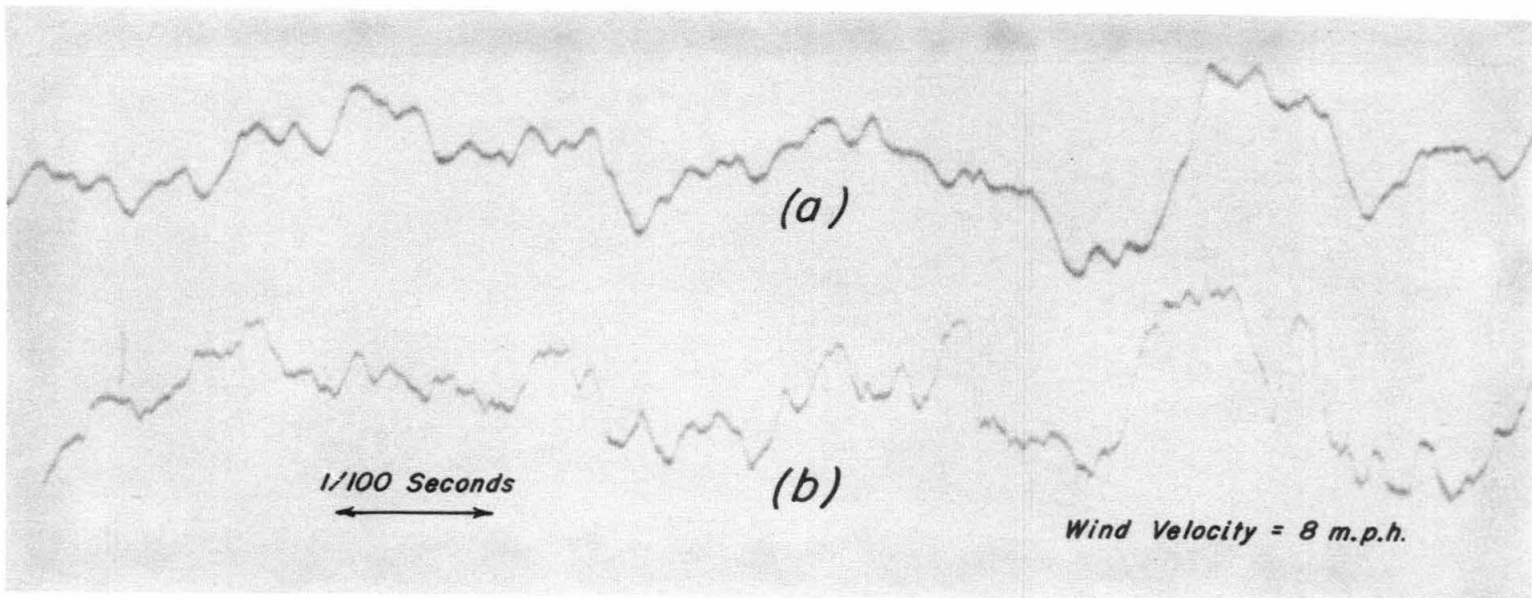
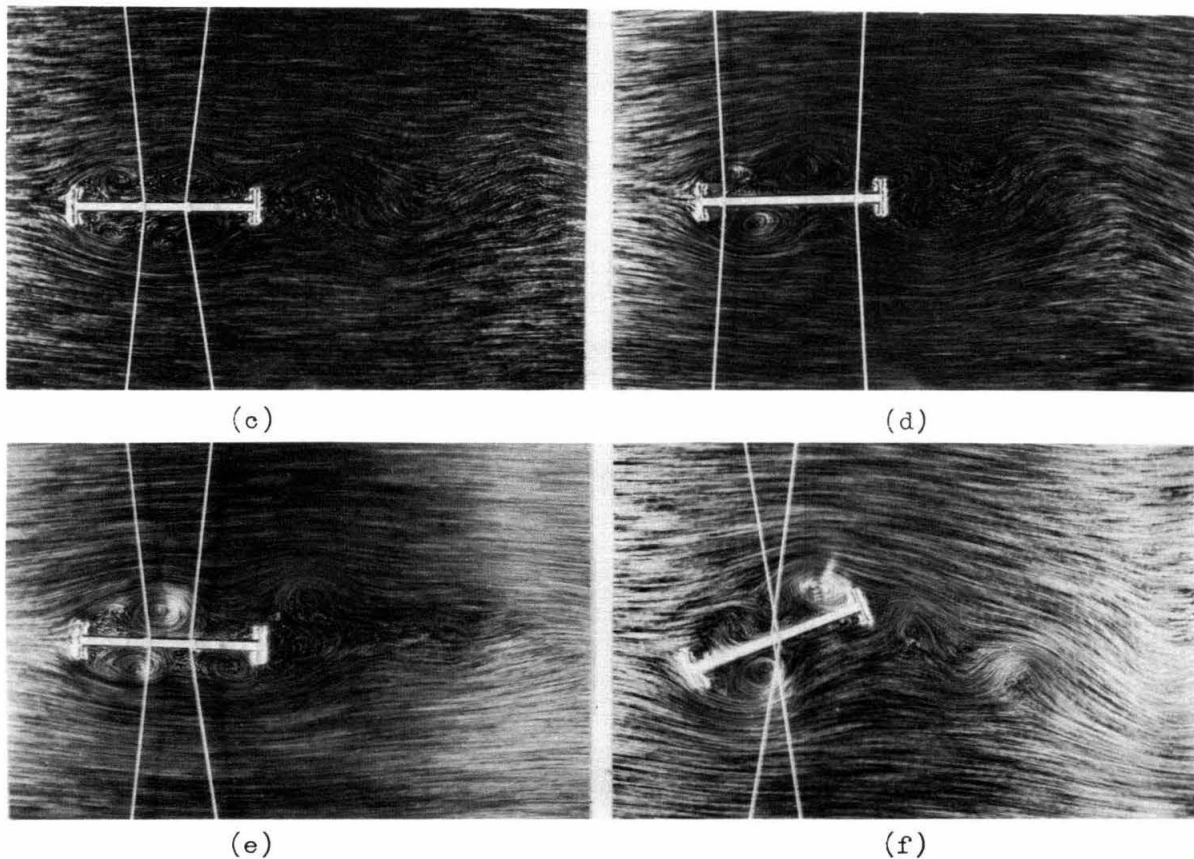
Fig. 25. Hot-Wire Records and Flow Pictures. (a), (b) - Velocity fluctuations behind the upper (a) and lower (b) edges of the front girder. (c) - Symmetric eddy formation on model at rest. (d), (e), (f) - Eddy formation at oscillating model. Note in (d) and (e) the asymmetry in eddy formation connected with incipient angular oscillation.

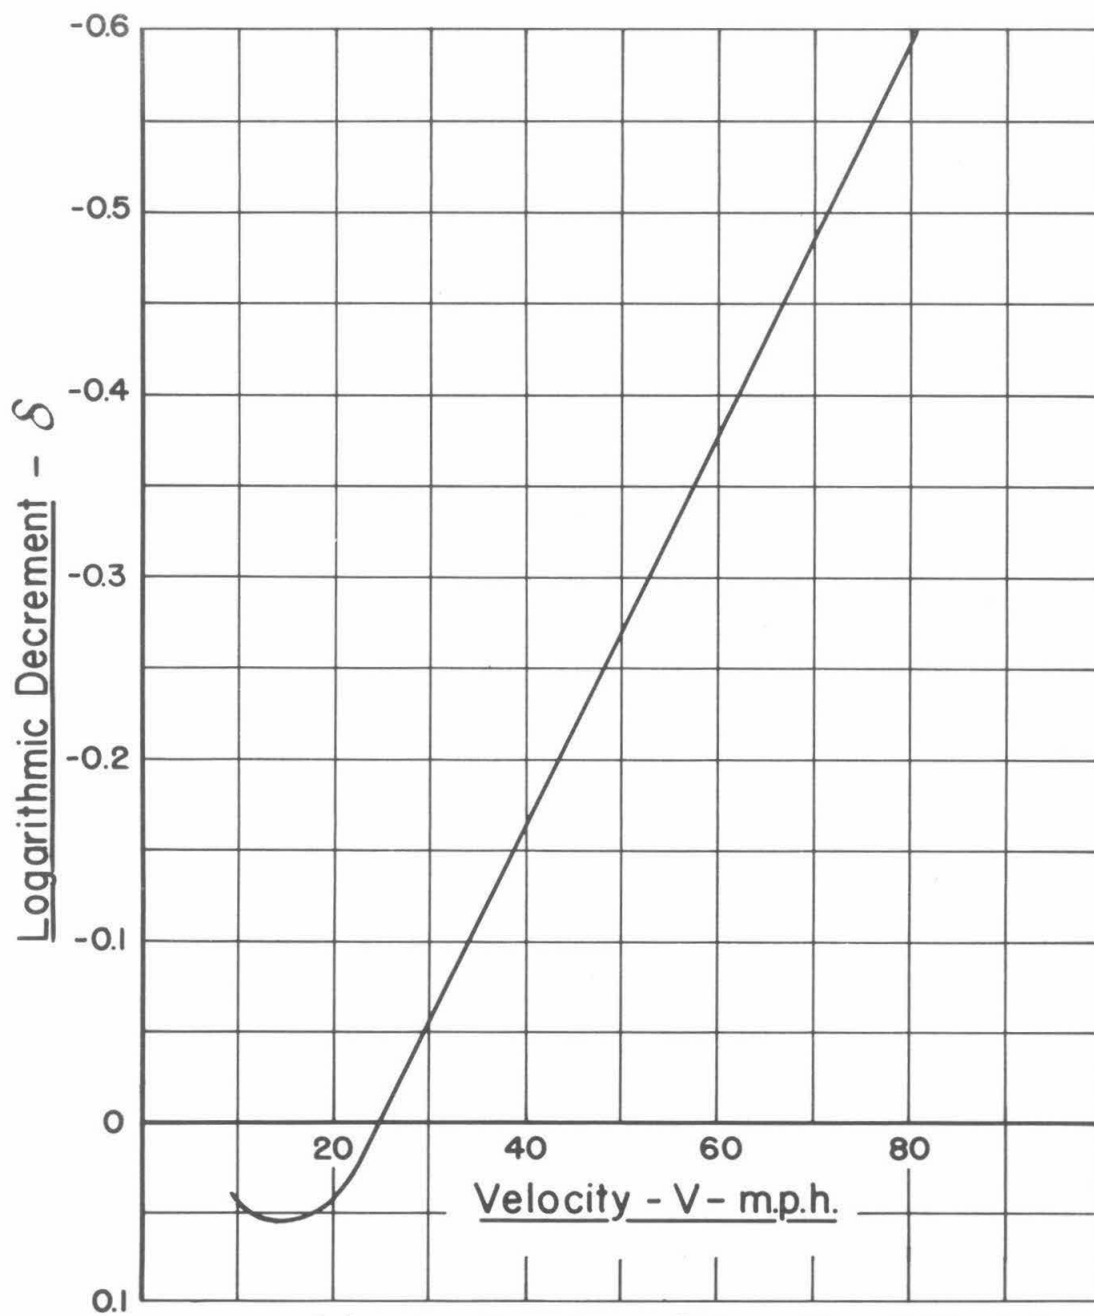
Fig.28 - Application of Results of Model Experiments to the Prototype - Tacoma Narrows Bridge.

The application to the prototype is based on the assumption that the flow pattern around geometrically similar bodies is geometrically similar, independent of scale. Deviations from this similarity are in aeronautical practice called scale-effect, or Reynolds number effect. In general the scale-effect is very considerable if the flow is governed by the viscosity of the air and less significant when the dynamic pressures control the flow. The probable error made in transferring the results from models to prototype both in the case of the vertical

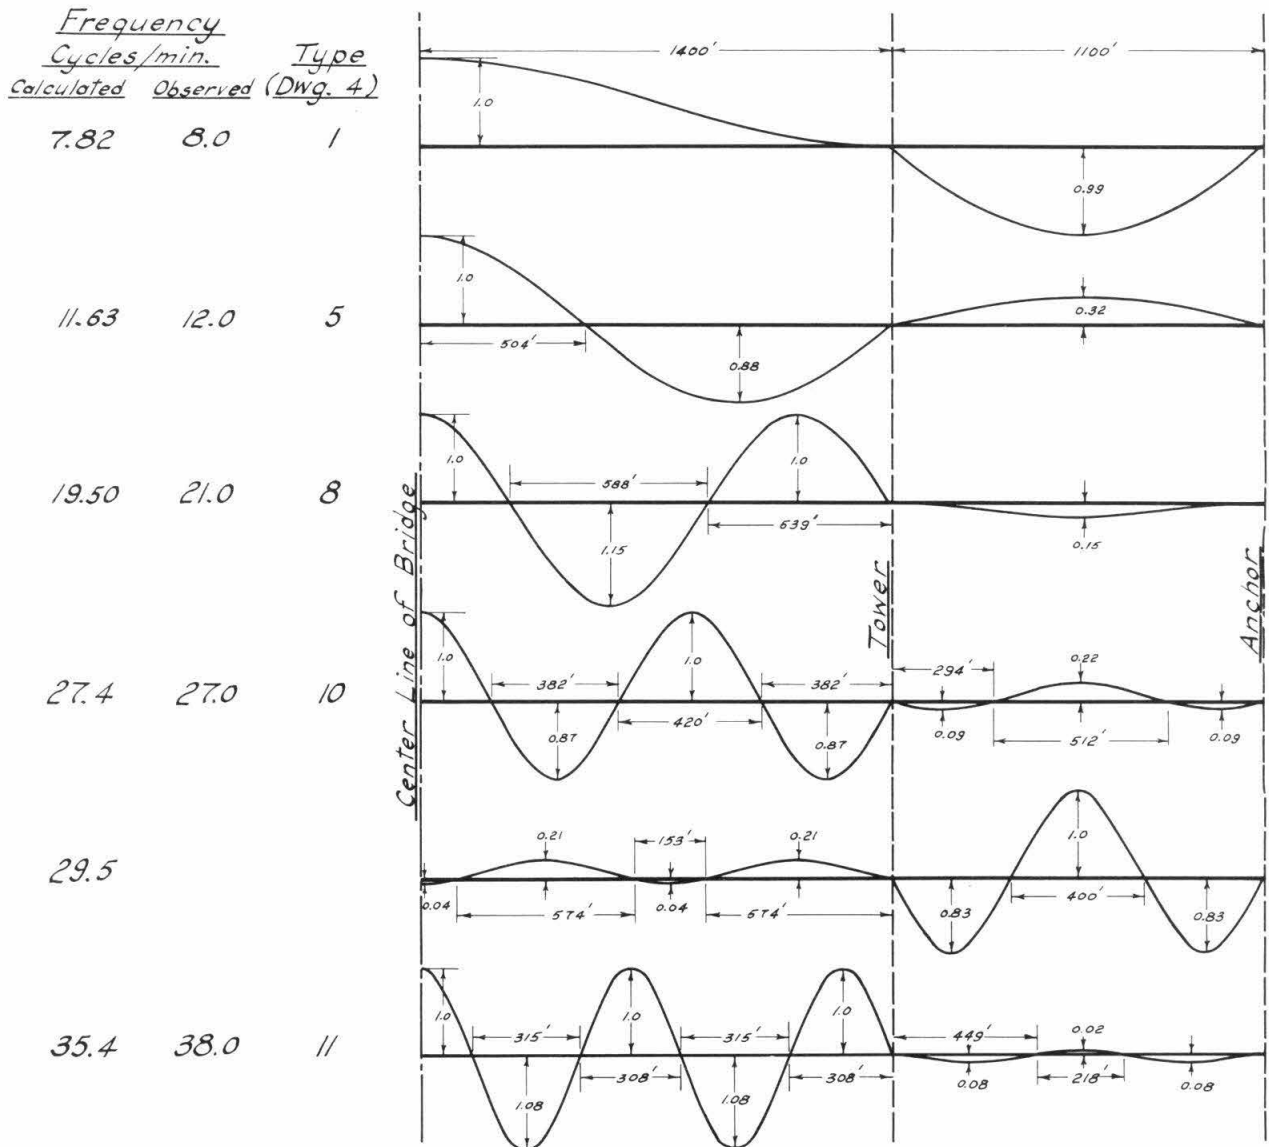
FIG. VI-2  
CALCULATED ASYMMETRIC MODES 1  
(MIDPOINT OF CABLE FREE)

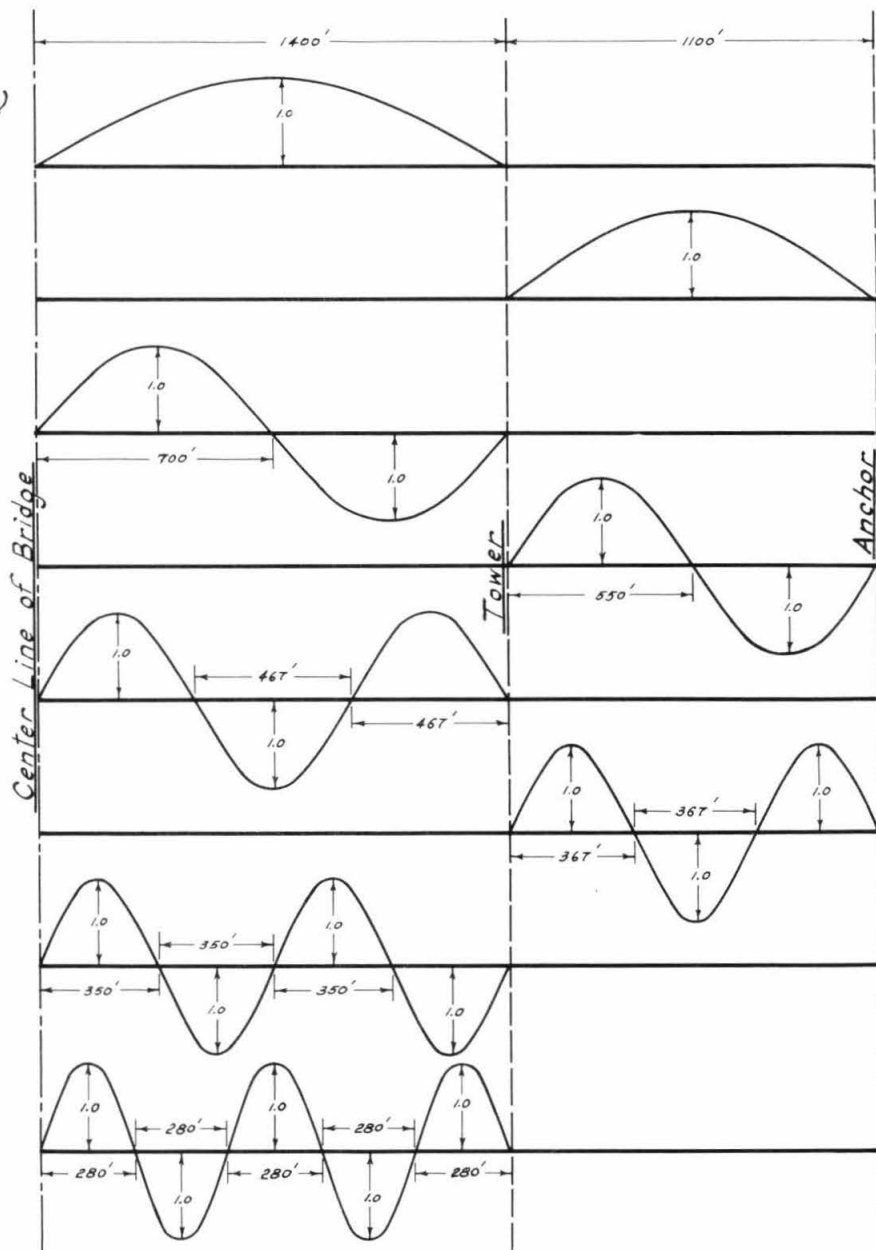
FIG. VI-3

CALCULATED ASYMMETRIC MODES 2  
(MIDPOINT OF CABLE TIED)

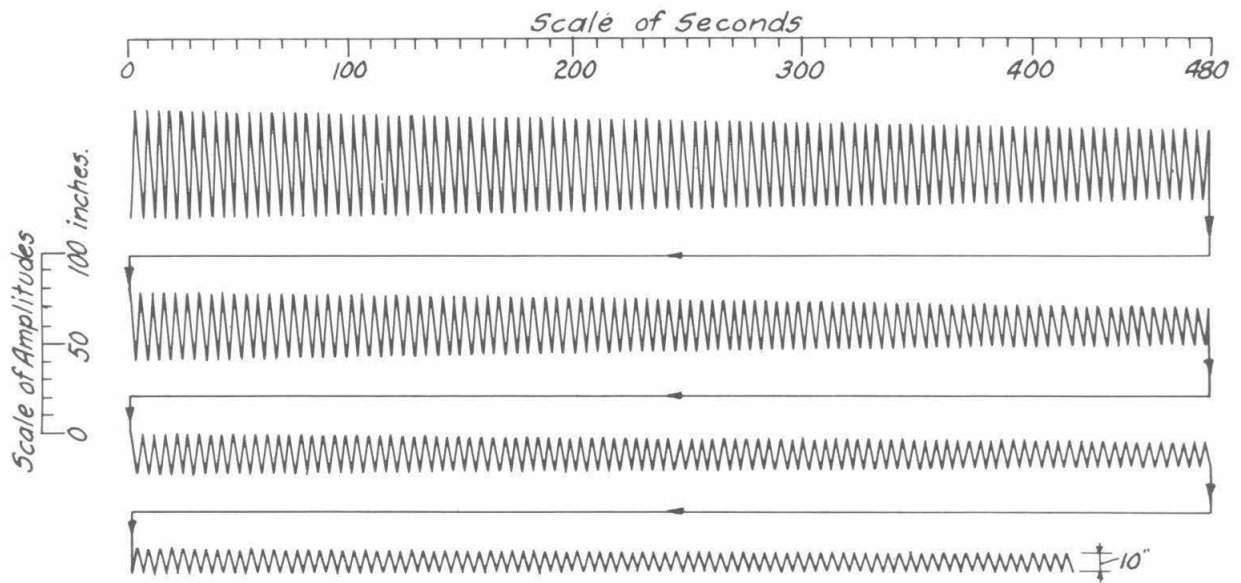
FIG. VII-2 - OSCILLATION DISSIPATION CURVES FOR DIFFERENT STAY ROPE ARRANGEMENTS OF THE TACOMA NARROWS BRIDGE.

Weight per lineal foot of bridge = 5700 lbs.  
Amplitudes diminish to 10" in 1860 seconds.

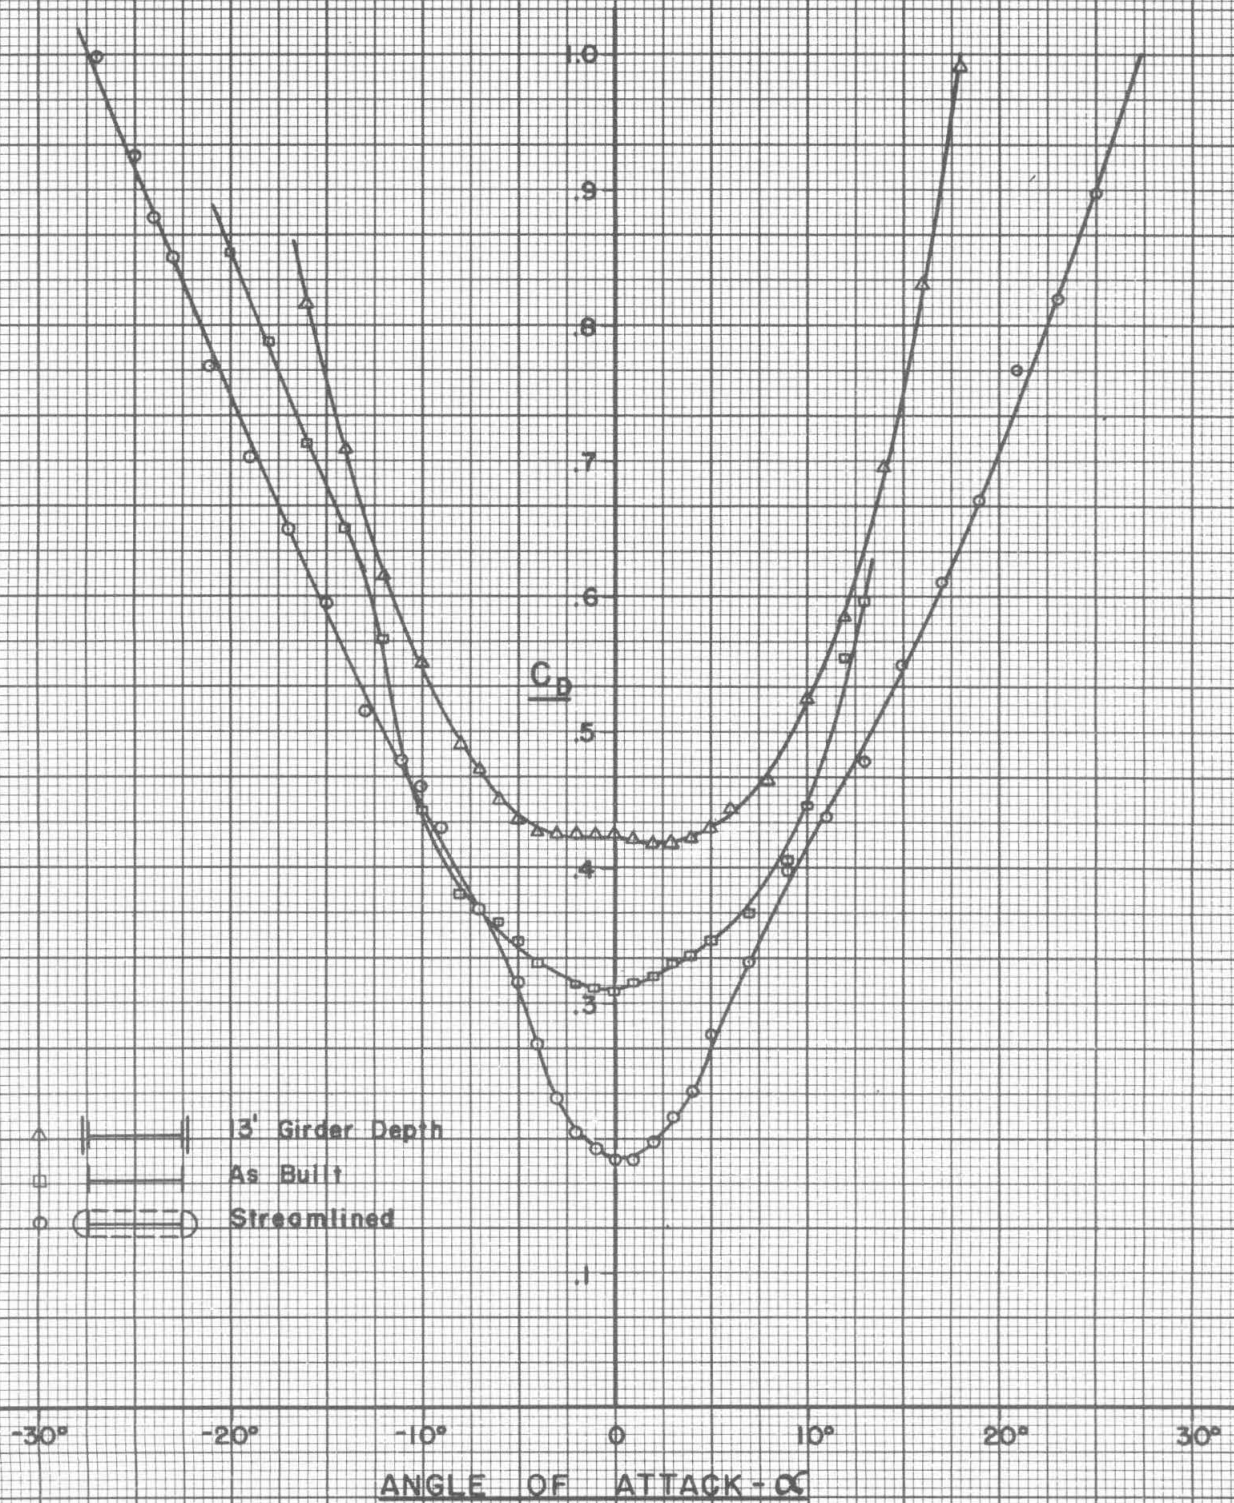
FIG. VIII-17  
DRAG CHARACTERISTICS  
OF VARIOUS SECTIONS  
FROM GALCIT TESTS
